Serious Near Miss – Defective Sliding Roof

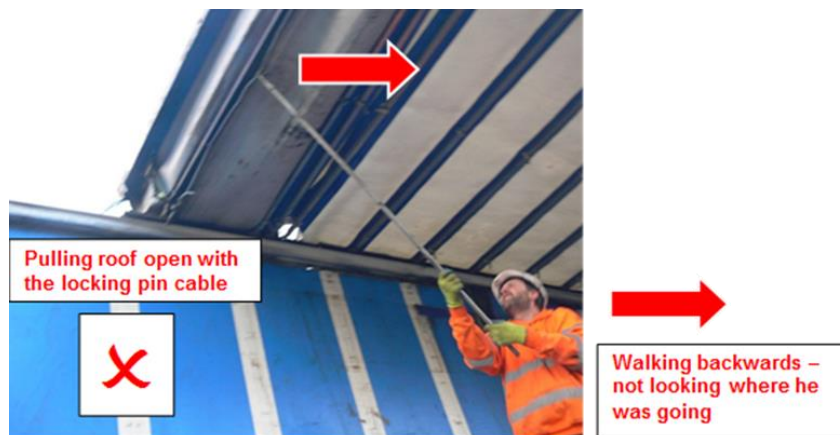
Picture taken from AB/013/2017

The driver unlocked the roof using the wire and put his roof pole in place and proceeded to pull the roof open whilst walking backwards. The roof was stiff and jammed. The loading site staff gave him their roof pole to use which was longer, while the site staff assisted by pushing on the roof bars with timber posts. The roof pole broke and the driver fell backwards onto the trailer bed. Luckily he was not hurt and able to carry on with his duties.

- The roof had been tested at the induction centre but not opened fully
- Driver was walking backwards pulling the roof open
- The roof had a defect which caused it to jam
- When excessive pressure was applied to the roof pole, the pole broke causing the driver to fall backwards
- On inspection by the trailer repair service, faulty parts were found in the roof mechanism and replaced

- ✓ Ensure drivers actively report defects they find on trailers for repair
- ✓ Re-emphasize the importance of following the correct safe working procedure for opening and closing sliding roofs. P&O Ferrymasters Ltd safe working procedure and what to do in the event of a fault guidance is available from our website: <http://www.poferrymasters.com/carrierinfo/safe-working-procedure-swp-0022.pdf>
- <http://www.poferrymasters.com/carrierinfo/sliding-roof-fault-finding.pdf>
- ✓ Inspect and promote regular inspection of trailers sliding roofs and roof poles for damage and defects.
- ✓ **Never** work on open sided trailers without fall prevention equipment.
